## Forklift Battery Explosion

**Incident Description:** Associate had just removed a forklift battery charging cord from a charging unit and was plugging it back into the lift, when the battery exploded.

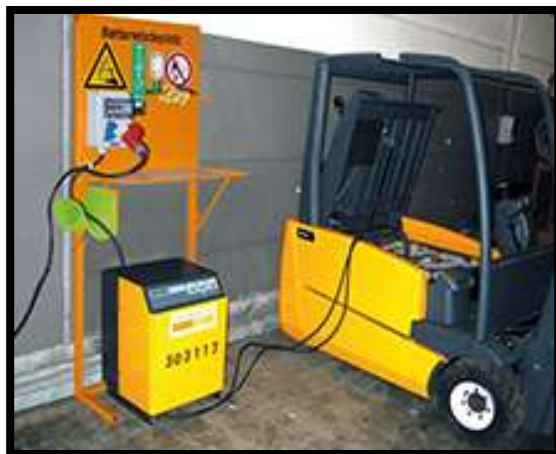
**Root Cause:** A small arc occurred when the forklift battery cover was closed over the battery charging electrical cord, causing damage. The arc caused the hydrogen emitted during the charging process to ignite, resulting in an explosion.

- 1) Keep charging areas properly ventilated; it is recommended all locations fan their battery charging areas to create an appropriate amount of air flow to effectively displace built up hydrogen. Follow this link for an example of a large, effective ventilation fan: [Ventilation Fan](#)
- 2) Battery covers should remain in the open position while batteries are charging
- 3) All electrical cords must be free of any cuts, frays, or shorts. If damage is identified, place the equipment out of service until it is repaired
- 4) Battery vent caps should be inspected to ensure they are working properly
- 5) All open flames must be prohibited in the charging area, including hot work
- 6) When charging, forklift must be properly positioned, emergency brake set, and turned off
