## Bypassing Safety Guards/Features

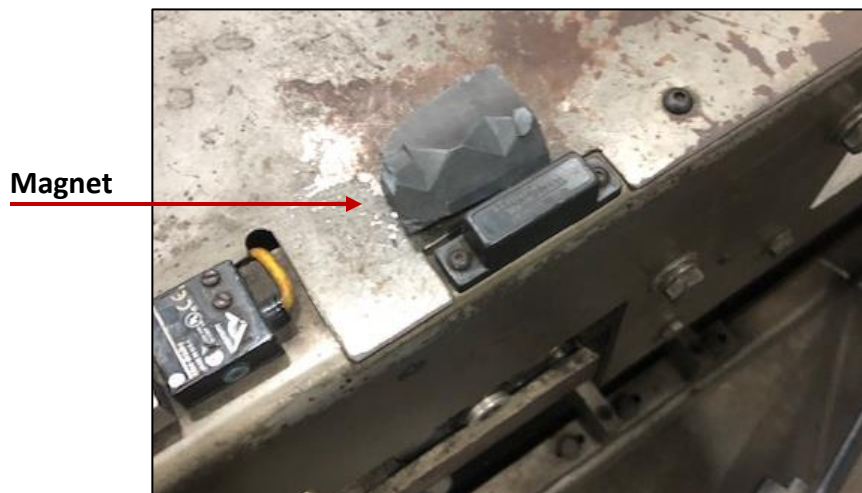
The associate clearing the jam, when opening the plexiglass guard and triggering the magnetic shutoff feature, was placing a separate independent magnet on the ARPAC machine to “fool” it into believing the plexiglass guard was in still in place.

This action allows the Associates to place their extremities into actively moving mechanical parts that could result in loss of life or limb.

**Root Cause:** Insufficient/Inadequate training of Saddle Creek Associate and Supervisor

- Saddle Creek will never instruct or allow associates to bypass any types of safety devices/functions that are affixed to mechanized equipment, no matter the reason!
- If you observe someone bypassing a safety devices/functions, report it to your supervisor immediately
